MEMORANDUM ASBESTOS SURVEY FINAL REPORT CNC CHARLESTON SC
3/1/1998
ENVIRONMENTAL DETACHMENT CHARLESTON

Subj: **ASBESTOS SURVEY FINAL REPORT, Charleston Naval Base Housing**

NAVAL HOUSING CHARLESTON NAVAL BASE CHARLESTON, SOUTH CAROLINA

ASBESTOS INSPECTION REPORT

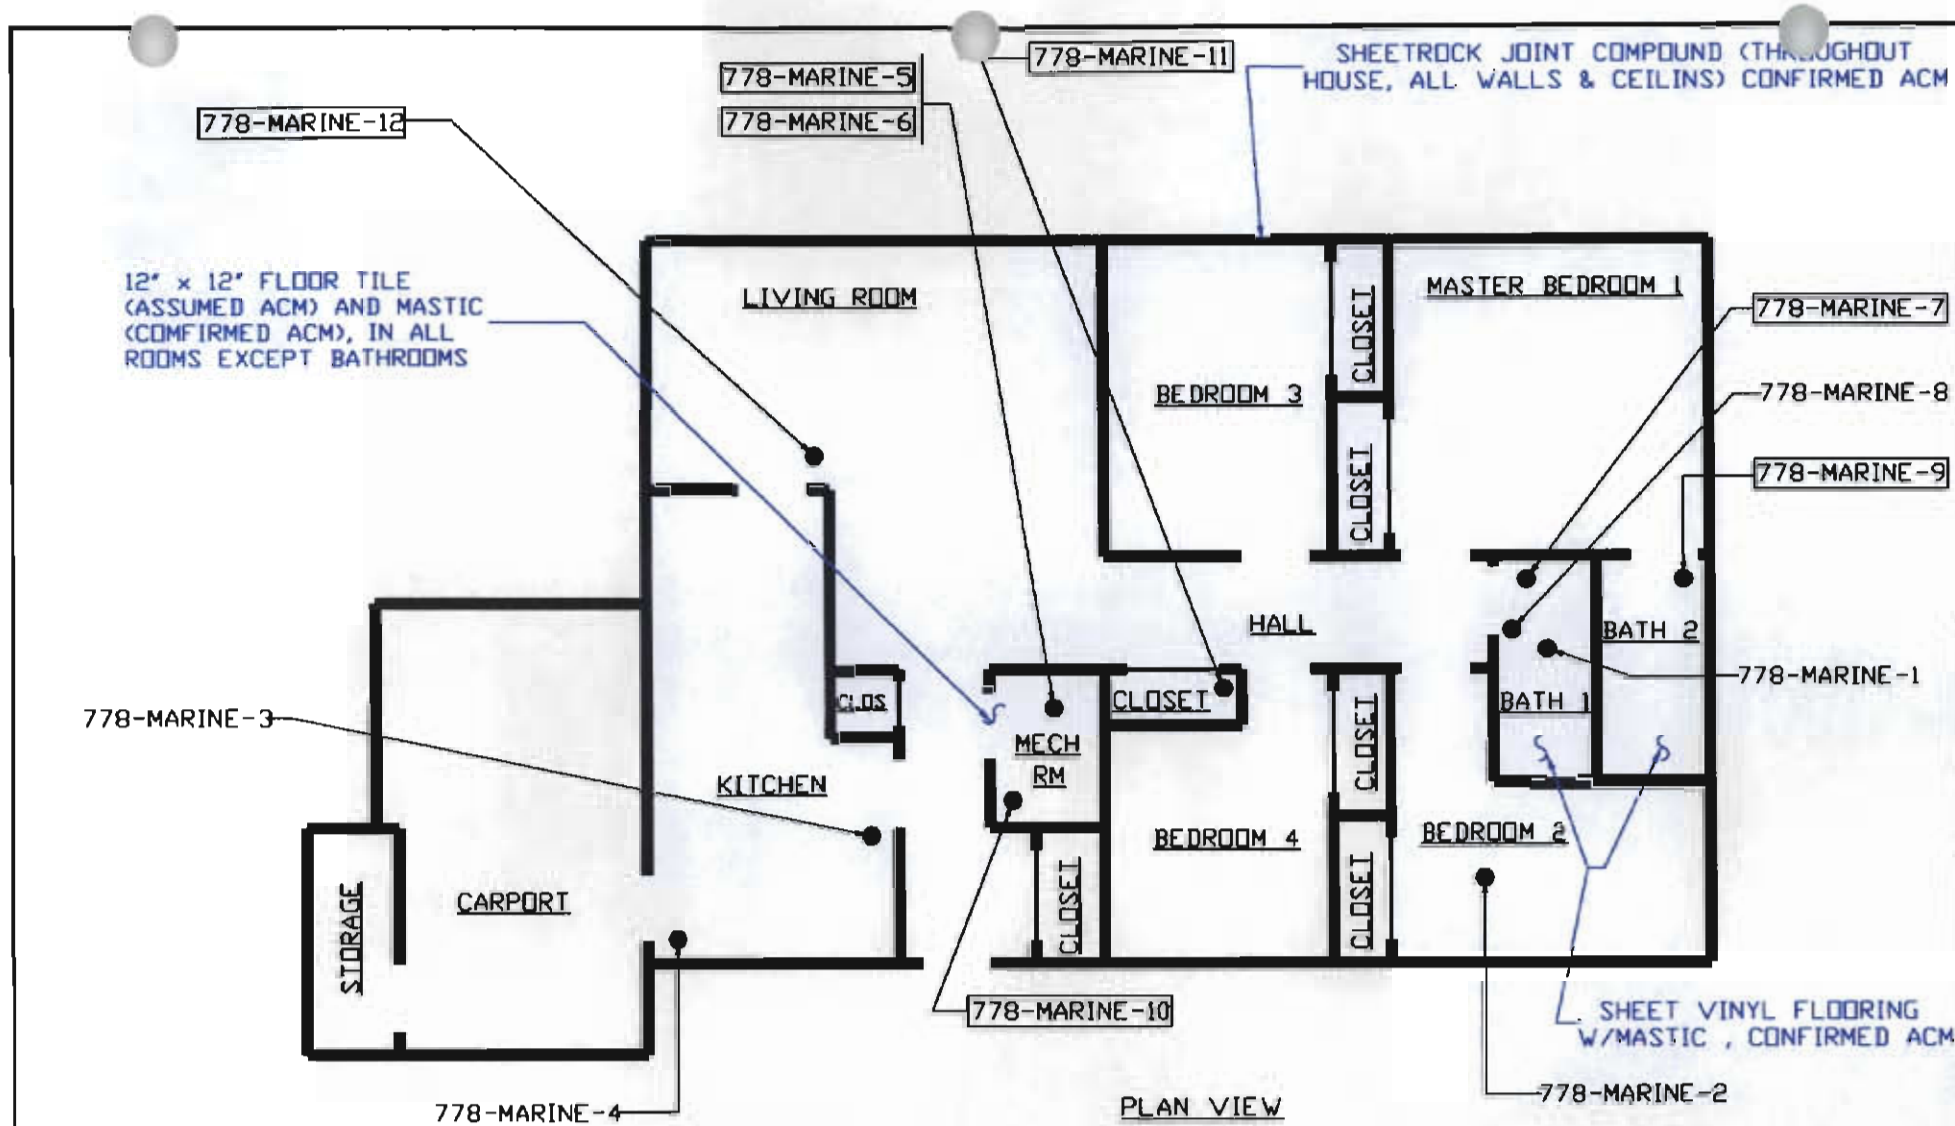
SPORTENVDETCHASN 1899 North Hobson Ave. North Charleston, SC 29405-2106 Ph. (803) 743-6777	Floor Plan 778 MARINE DR. Charleston Naval Base Charleston, SC	
	DWG DATE: XXXXXXXX	DWG NAME: ASB 778

Sample No.	ACM Y/N /A	Material Description / LOCATION	Quantity	AHERA CATEGORY	FRIABLE	Cond	% D	Recommended Action	Comments
774-MAR-3 774-MAR-4 774-MAR-5 774-MAR-6	Y Y Y Y	MISC. FLOOR TILE, for 12" x 12" floor tile, all rooms except bath rooms	1432 sq. ft.	8	N	G	<1	Repair Damage, O & M	2 sq. ft. damaged near water heater Note: mastic tested positive, tile <i>assumed</i> positive
ASSUMED	A	MISC. FLOOR TILE, 12" x 12"	1432 sq. ft.	8	N	G	<1	Repair Damage, O & M	2 sq. ft. damaged near water heater Note: mastic tested positive, tile <i>assumed</i> positive
778-MARINE-7 778-MARINE-8 778-MARINE-9	Y N Y	SHEET VINYL FLOORING and MASTIC, bathrooms # 1 and #2	40 sq. ft.	8	N	G	0	O & M	
778-MARINE-10 778-MARINE-11 778-MARINE-12	Y Y Y	MISC. SHEETROCK JOINT COMPOUND, walls and ceilings throughout house	5632 sq. ft.	8	N	G	0	O & M	See General Note 1
